Figure 9
Nitrate Concentrations
and Watershed Restoration
Saucony Creek Watershed
Berks County, PA

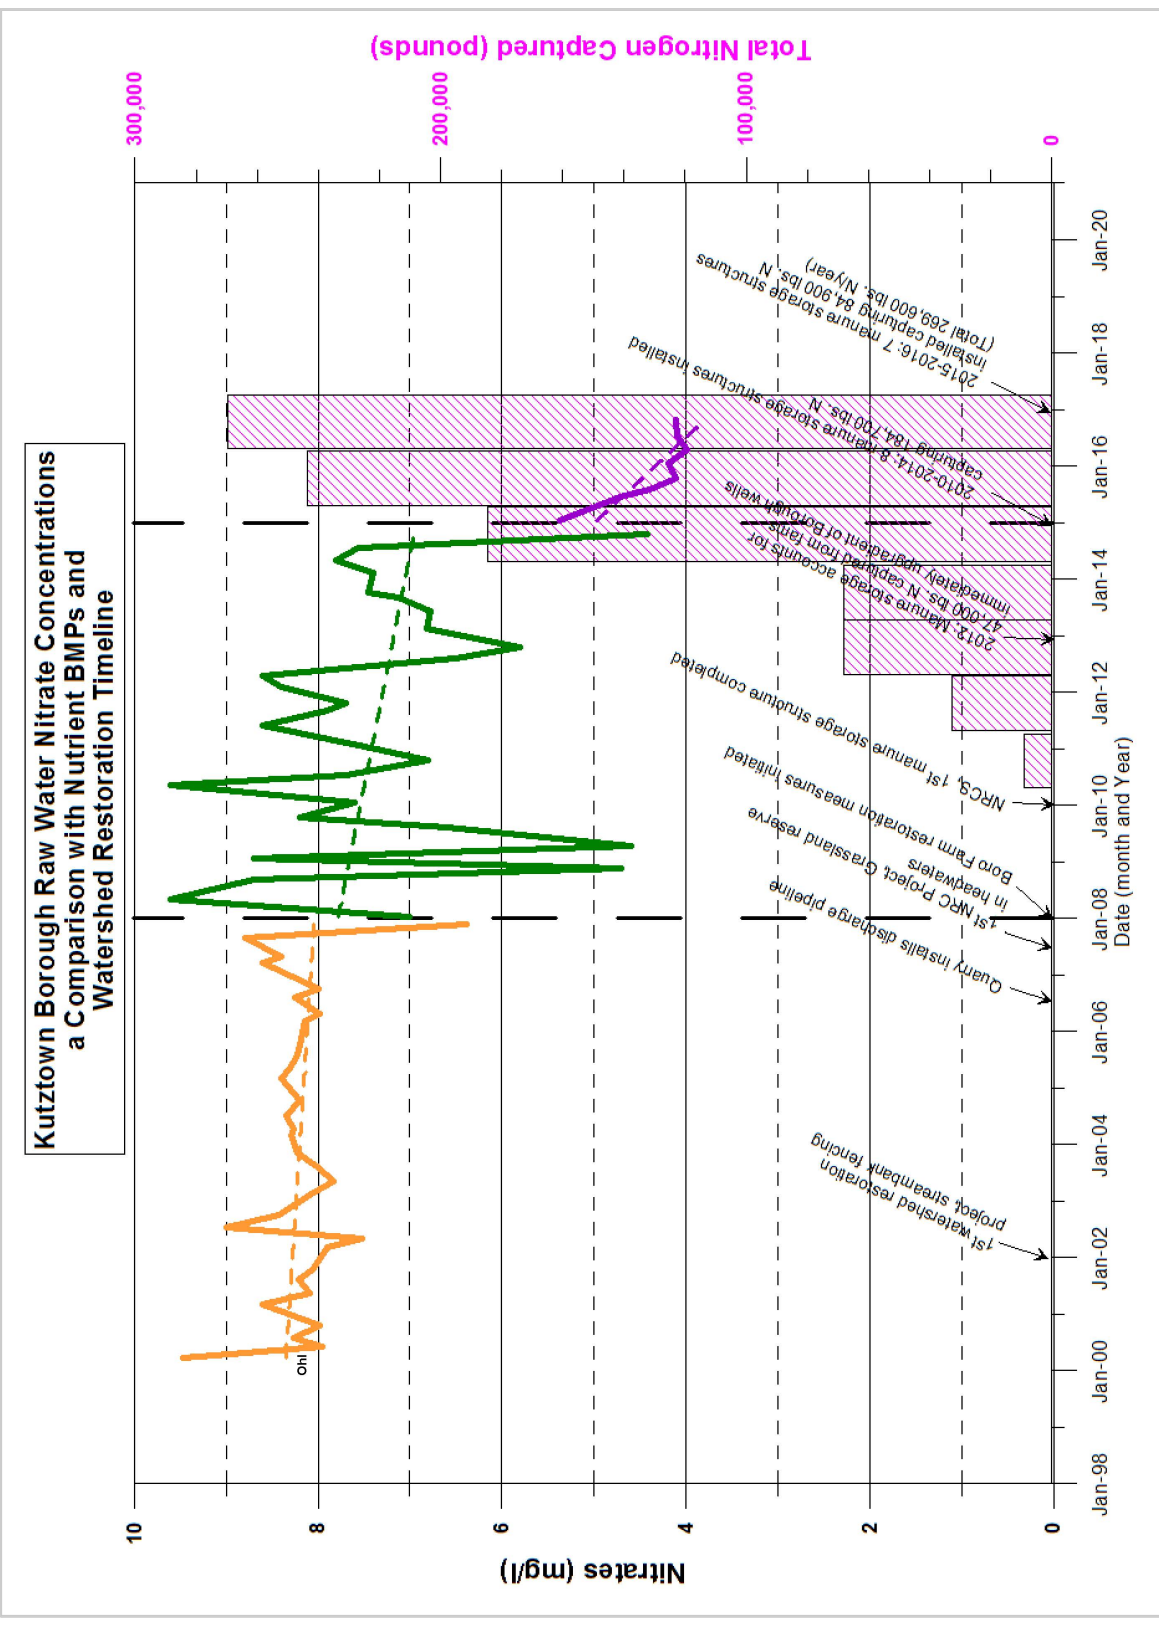
Nitrogen Capture

- 2000 - 2007 NO₃-N (mg/l)
- 2008 - 2014 NO₃-N (mg/l)
- 2015 - 2016 NO₃-N (mg/l)
